**TESTON THE FISH-FRIENDLINESS OF THE PUMPS**  
**OF PUMPING-STATION DE NIEUWE HORN**

Project Name : Renovation pumping-station De Nieuwe Horn

Specification : T001-4737931  
Our Reference : 4111397  
Test Date : 20-11-2013  
Report Date : 26-11-2013

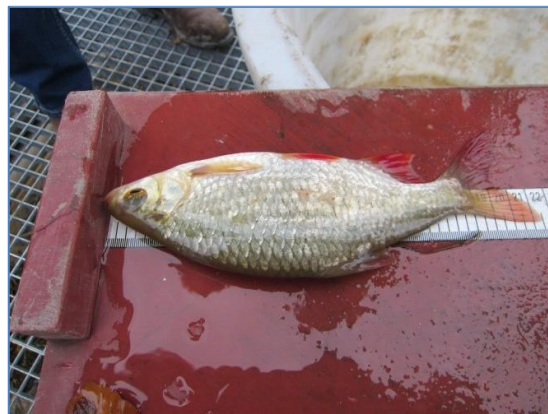
Figure 6.

Fish Species	Length (cm)	No Damage	Scale Damage		Total Quantity	Comments
			By pump	Bynet		
Bream	10-14	2			2	Light scale damage by the net (figure 6).
	15 - 19	1		1	1	
Perch	27	1			1	
Roach	22	1			1	No damage visible, death by entrapment of the head in the net (figure 7).
Pike-Perch	15	1		1	1	
Total		6		2	6

One fish showed scale damage which was most likely caused by the net. Given that the fish were not checked before capture, it cannot be said with certainty whether the lesions were already present on the fish. The damage, however, looked 'fresh'. The fish did not show the kind of damage normally caused by pumps.

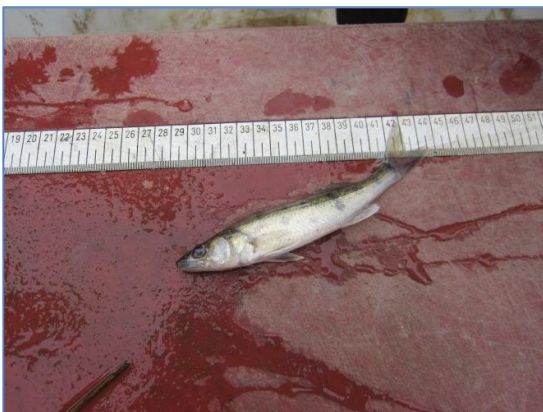
Figure 7.

Another fish showed no injury but was dead. The fish had his head stuck in the net and tried to escape in vain, with resulted in death. This is shown as scale damage in the table.

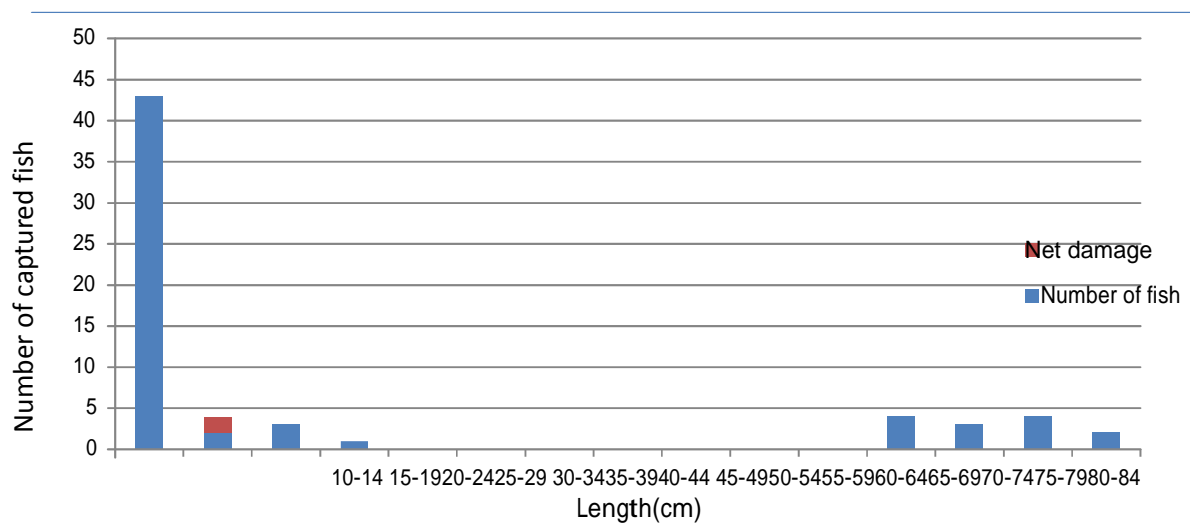
Table 5.1 shows the total number of fish captured, the classification is based on natural features and Eels have been added in length groups.
