Fish swim back and forth again

Final report of the practical test of innovative facilities in pumping stations

Report 2011-096

3.4 Kralingse Plas Pumping Station

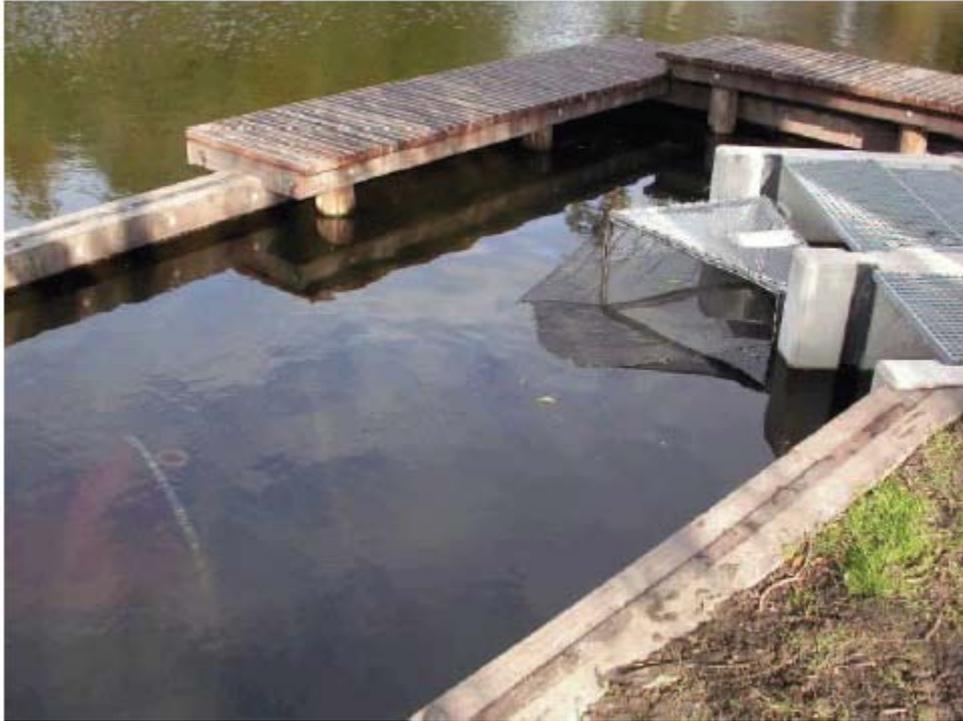
Figure 9 Trapping structure behind the outflow orifice of the Kralingse Plas pumping station (photo: Koeman and Bijkerk).

Located between the basin lock and the marina, in the southwest corner of the Kralingse Plas in Rotterdam (see Annex I). The pumping station pumps excess water from the Kralingse Plas (circa 100 ha) into the Rotte (Figure 9). The pumping station was equipped with a Flygt submersible pump with a capacity of 25 m³/min. The water head is of circa 1.60 m.
